**Flood Control Project Maintenance
Levee Inspections
LMA District Cover Sheet
Spring 2010 Levee Inspection Results**

Sutter Maintenance Yard Maintenance Area 0017

Waterway			Bank	Unit Miles
Unit No. 01 Lake County Sutter Maintenance Yard - Middle Creek			Left	3.90
	Spring (March - May)	Summer (June - August)	(September - November) Fall	Winter (December - February)
Unit Maintenance Rating (Fall Only)				
Date of Inspection	5/18/2010 - 5/18/2010			
DWR Inspector	Bob Duffey			
Accompanied By	Bryan Reniff Sutter Yard

Levee Inspection Report By Mile - Spring 2010

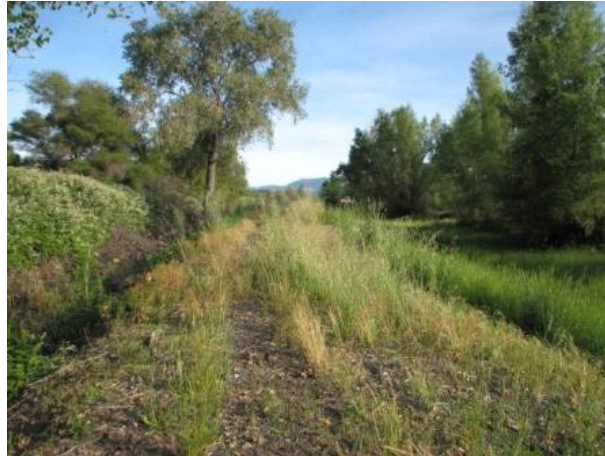
Levee Mile Report Line	1
Start Levee Mile	4.18
End Levee Mile	7.30
Location	Water Side
Category	Earthen Levee
Item	Trim / Thin Trees

View of the vegetation on both sides of the levee & water on the toe of the levee in one location.

LMR No	Levee Mile		Category	Item	Location *	Rating **	Action/Comment	GPS Latitude/Longitude		Issue No. Photo
	Start	End						Start	End	
1	4.18	7.30	Earthen Levee	Trim / Thin Trees	WS	U	Thin trees to allow visibility of the ground and room to flood fight.	39.142155 ° -122.902343 °	39.118735 ° -122.884892 °	2 Y
2	4.18	7.31	Earthen Levee	Vegetation	WS	U	Remove the wild growth other than native grasses from the levee slopes.	39.142155 ° -122.902343 °	39.118675 ° -122.884772 °	1 Y

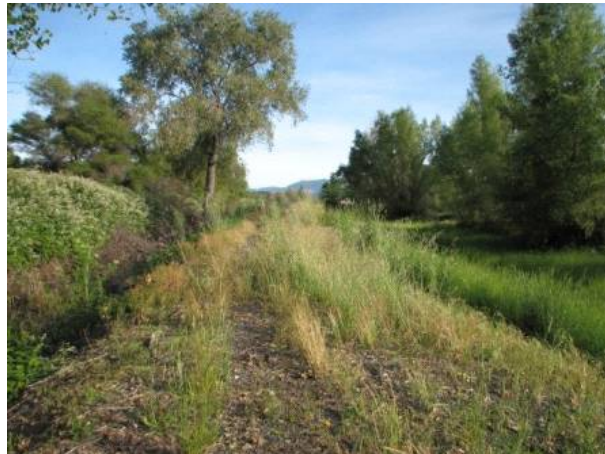
Levee Mile Report Line	1
Start Levee Mile	4.18
End Levee Mile	7.30
Location	Water Side
Category	Earthen Levee
Item	Trim / Thin Trees

View of the trees on the waterside slope of the Levee.

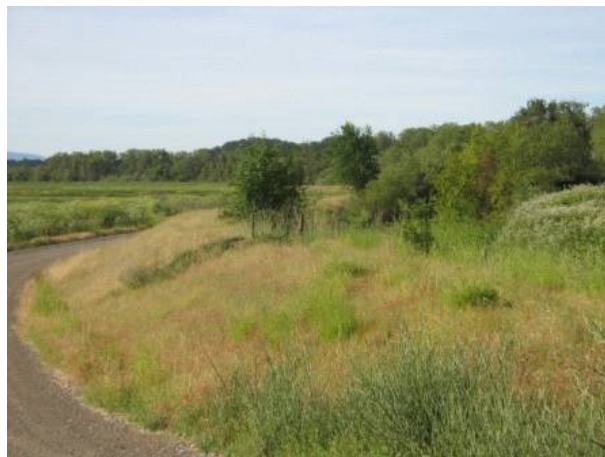
Levee Mile Report Line	2
Start Levee Mile	4.18
End Levee Mile	7.31
Location	Water Side
Category	Earthen Levee
Item	Vegetation

view of the six-foot crown levee & heavy vegetation on waterside slope.

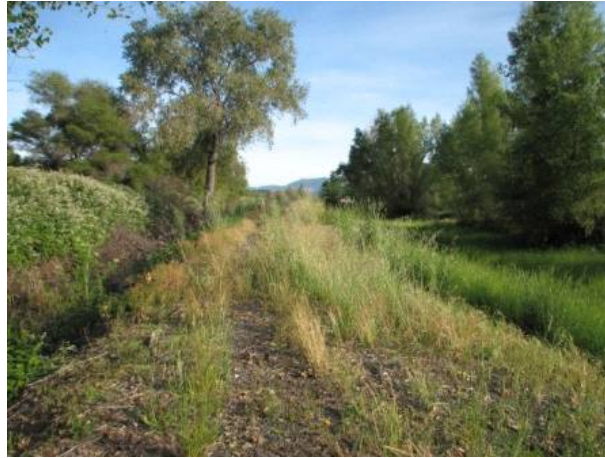
Levee Mile Report Line	2
Start Levee Mile	4.18
End Levee Mile	7.31
Location	Water Side
Category	Earthen Levee
Item	Vegetation

View of the vegetation on the both slopes of the levee.
